# Long Lake Shoreline Inventory

## PREPARED FOR:

Rice Creek Watershed District  
4325 Pheasant Ridge Drive, Suite 611  
Blaine, Minnesota, 55449-4539

Ramsey Conservation District  
1425 Paul Kirkwold Drive  
Arden Hills, MN 55112  
651-266-7271

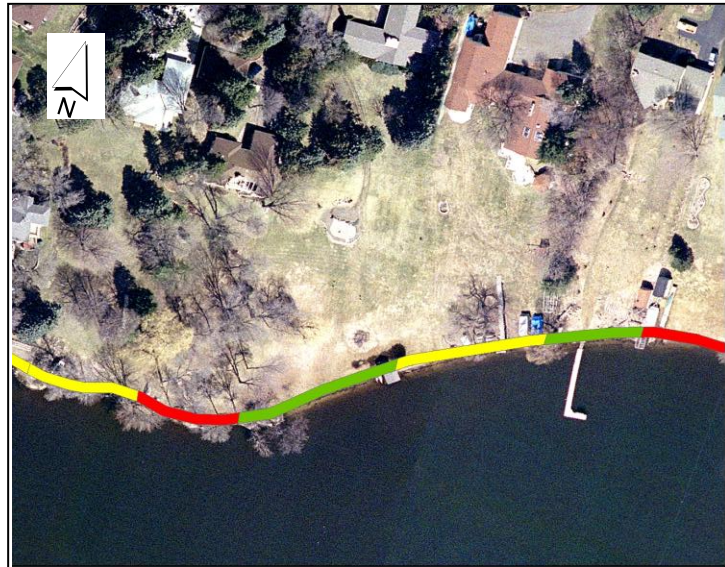
The overall findings within the bank zone show that out of the approximately 25,003 linear feet surveyed, 1,462 feet were classified as low, 18,087 feet were classified as medium, and 5,454 were classified as high for susceptibility to erosion (Table 2 and Figure 3). Out of the 5,454 linear feet that were classified as high, 1,526 linear feet lie within public parcels, and approximately 3,928 linear feet lie along private land. A detailed breakdown of the three variables that were added to create the overall ranking (land cover, soil type, and slope) within the bank and shore zone can be found in Table 2. The least abundant land cover type in the survey area is native vegetation, which makes up less than 1% of the overall land cover within the bank zone. Weedy

**Figure 3.** An area along Long Lake depicting the different classifications of erosion susceptibility, red represents high (10/11), yellow represents medium (8/9), and green represents low (6/7).

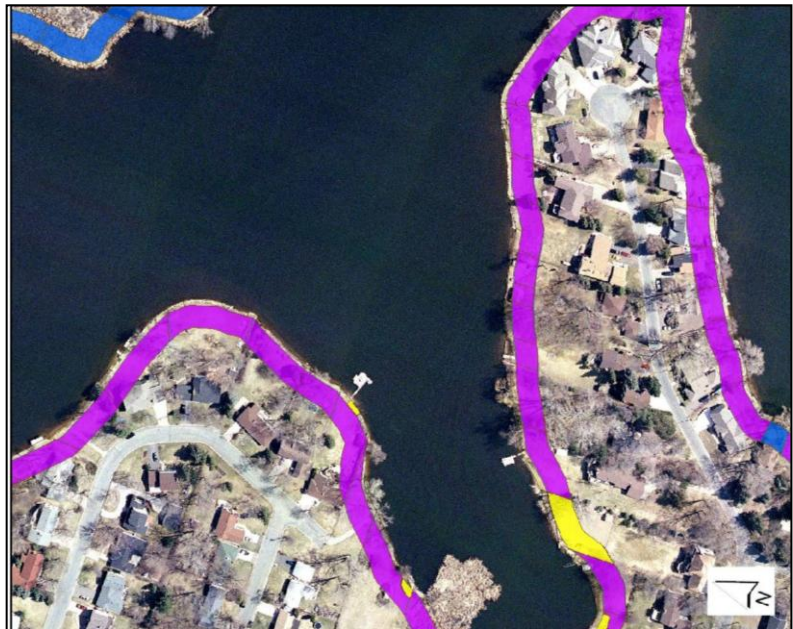
The shore zone consisted of approximately 980,808 square feet (22.52 acres) surveyed. Out of the 980,808 square feet classified, 289,656 square feet were classified as low, 608,490 square feet were classified as medium, and 82,752 square feet were classified as high (Table 2 and Figure 4). Of the shore zone classified as high, approximately 11,302 square feet is on public land, while 71,450 square feet lies on private land. There are seven different soil types that surround Long Lake. The majority of the soils have a K-factor of 0.17 which classified these areas with a rank of three. A small area of soils located in the northeast corner surrounding the lake are made up of Chaska silt loam, and therefore have a K-factor of 0.28. The soils that fell within the zones in these Chaska soil areas were ranked as a two.

**Figure 4.** An area along Long Lake depicting the different classifications for lack of buffering potential, yellow represents high (9/10), purple represents medium (7/8), and the blue represents low (5,6).

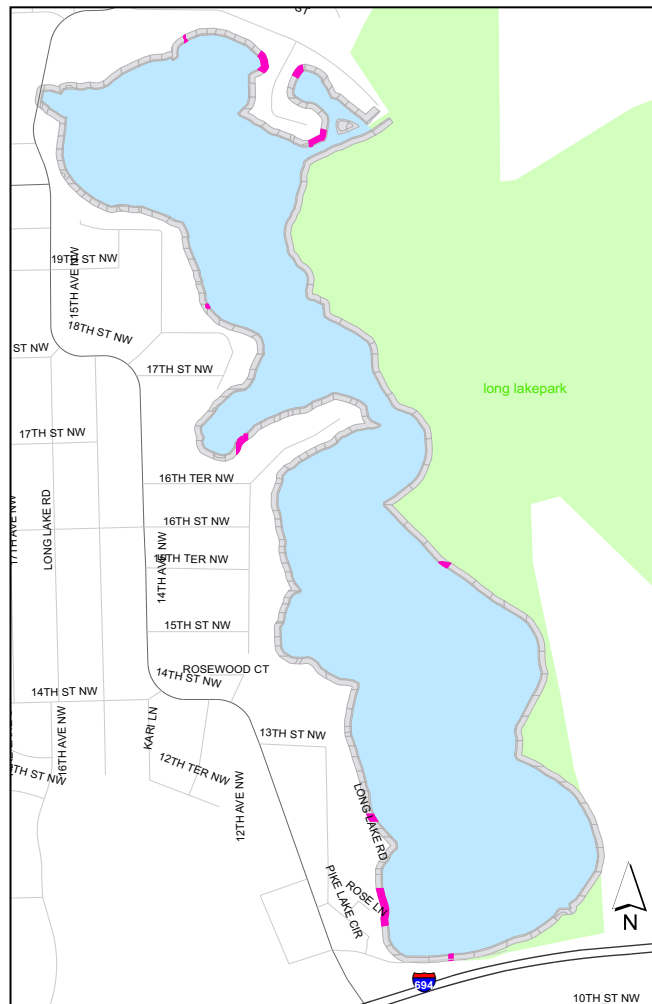
Parcels with a classification of 10 or 11 within the bank zone were most susceptible to erosion and thus would be ideal locations to implement shoreline restoration initiatives given the parameters. Within the shore zone it was determined that areas classified as a 9 or 10 have little or no buffering potential to prevent runoff from entering the lake. Several areas adjacent to the lake, approximately 1,814 linear feet, had both high potential for erosion within the bank zone and a low potential for filtering runoff within the buffer zone. A combination of these two factors can lead to accelerated erosion and should be considered as priority areas to implement restoration practices (Figure 5). If high costs and limited access (consent from private owners) poses a problem for future shoreline restoration, several areas located within public lands (approximately 1,526 linear feet) may be the most ideal locations to target for restoration (Figure 6).

**Figure 5.** Areas along Long Lake highlighted in pink were found to have high susceptibility to erosion and a low capacity for buffering runoff entering the lake.

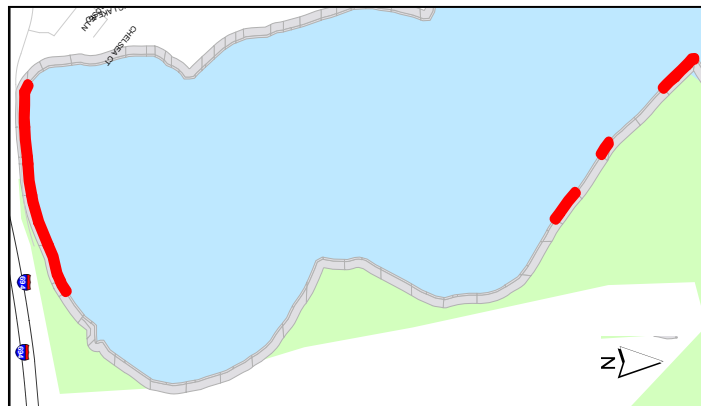
**Figure 6.** Areas in red are highly susceptible to erosion and located along public property, making them ideal for implementing restoration practices.

Surveyors noted that the cover on these high ranked public lands consisted of eroding paths to the water, sandy beaches, and impervious surfaces, which appeared to be adding to the erosion along the shoreline (Appendix 1.).

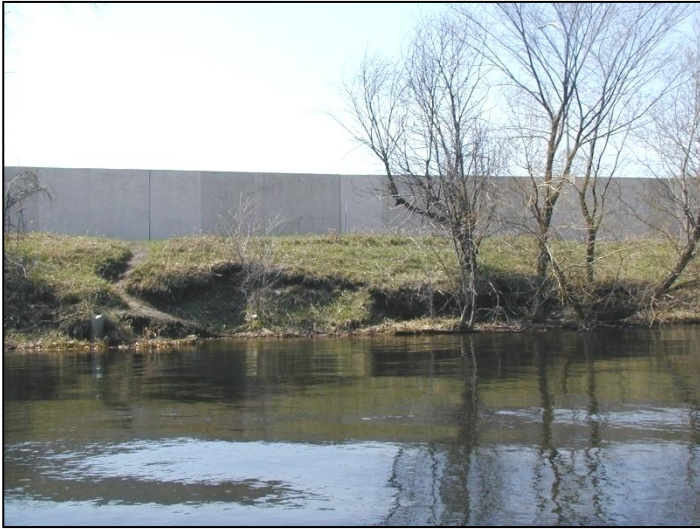
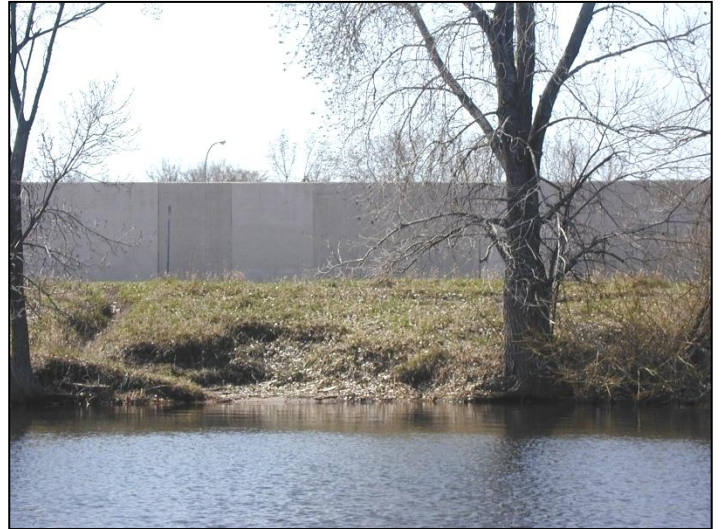
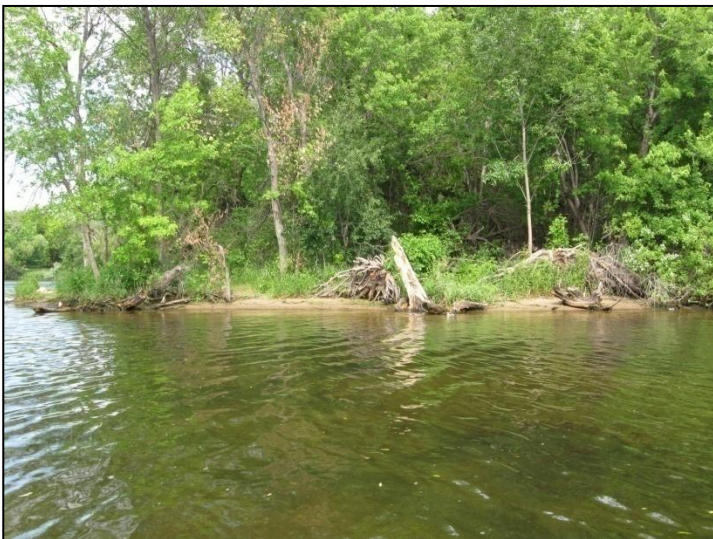
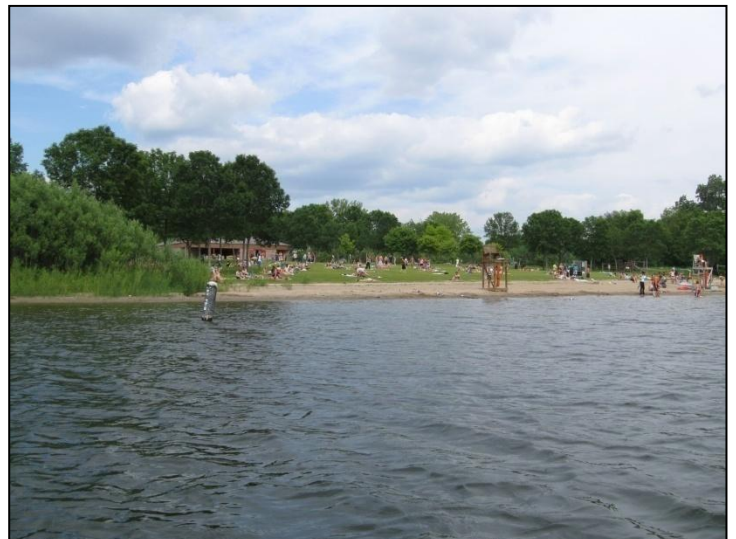
**Appendix A.** *Shoreline consisting of eroding paths and sandy beaches located on public property south and east along Long Lake.*
