# Long Lake Shoreline Inventory

## PREPARED FOR:

Rice Creek Watershed District  
4325 Pheasant Ridge Drive, Suite 611  
Blaine, Minnesota, 55449-4539

Ramsey Conservation District  
1425 Paul Kirkwold Drive  
Arden Hills, MN 55112  
651-266-7271

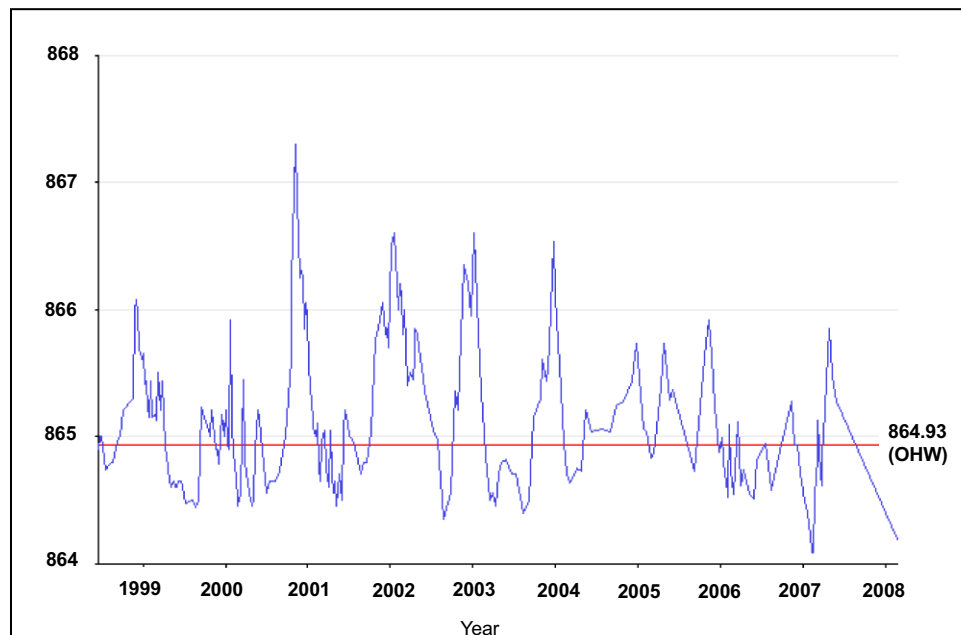
**Figure 7.** Lake levels from 1999 - Present.

information for Long Lake shows that there has been little deviation from the OHW mark (864.93 ft) so far in 2008, with 864.19 feet the lowest record taken in early September, and 865.95 feet recorded in early June. However, records for previous years have shown greater fluctuation (Figure 7). Although

these two factors are thought to be contributing to shoreline erosion, the degree of erosion caused by recreational boating and lake level fluctuation will remain unknown until further research can be conducted.
